CEDAR RAPIDS, IOWA, BPL Trial System Radio Frequency Interference Tests

Cedar Rapids BPL Steering Committee
June 18, 2004

The Cedar Rapids, Iowa, BPL Steering Committee ("BPLSC") sponsored a series of tests to demonstrate the degree of radio frequency interference ("RFI") occurring to a licensed Amateur Radio station located near the BPL trial site of Alliant Energy.

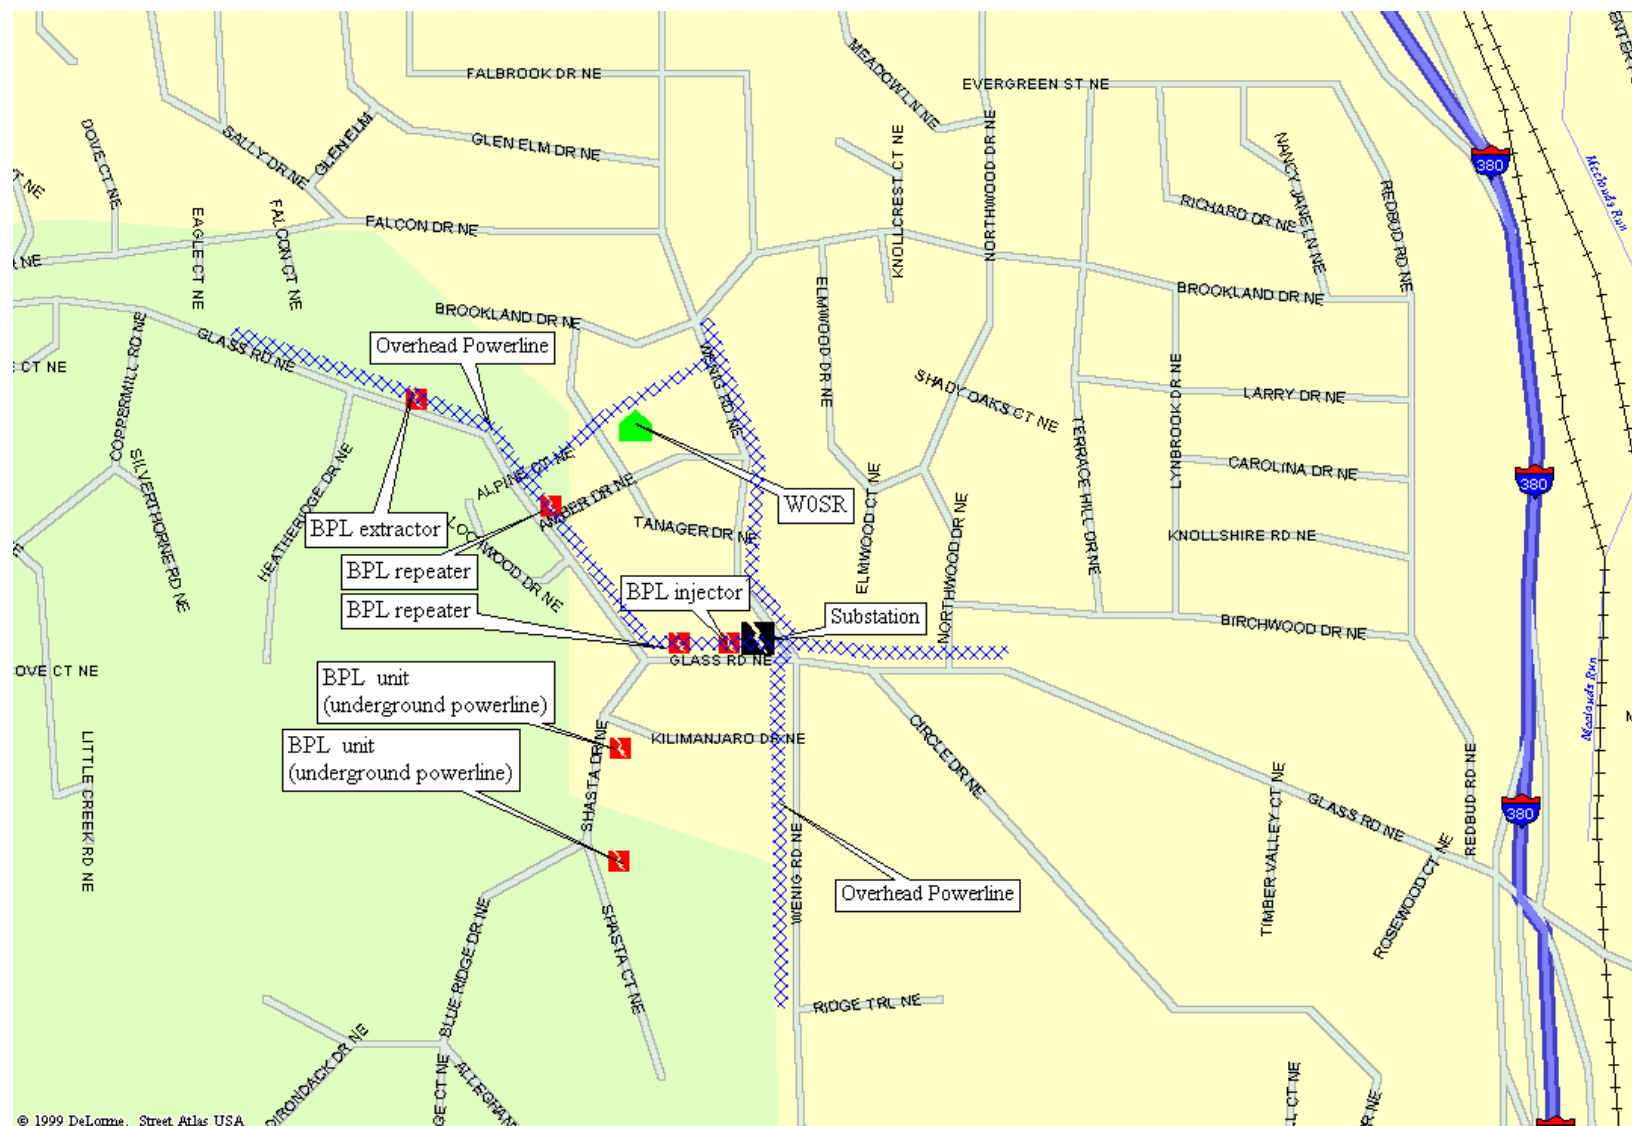
**Figure 3-1: Map of BPL trial area and location of the WØSR station and residence
(North is top of map.)**

The Alliant Energy trial BPL system includes a segment of overhead medium voltage distribution lines, as well as a short segment of buried medium voltage distribution lines. This BPL system is configured to interface with subscribers via Wi-Fi (antenna located on each test unit), and the system runs along Glass Road. Figure 3-1 is a map which shows the geographic relationship between the BPL trial system along Glass Road and Mr. Spencer’s residence. The map shows the location of the BPL trial system hardware as it existed at the time of testing, and it helps to understand the location of Mr. Spencer’s residence and antenna system relative to both the actual BPL trial lines and other neighborhood power distribution lines that connect to the BPL trial lines, but which are not intentional data carriers at this time.

Note that the Spencer residence is not located directly adjacent to any lines carrying the BPL test signals. Mr. Spencer’s antennas are approximately 183 meters (600 feet) from the Glass Road lines. They are approximately 30.5 meters (100 feet) from the distribution line which runs just northwest of the property.

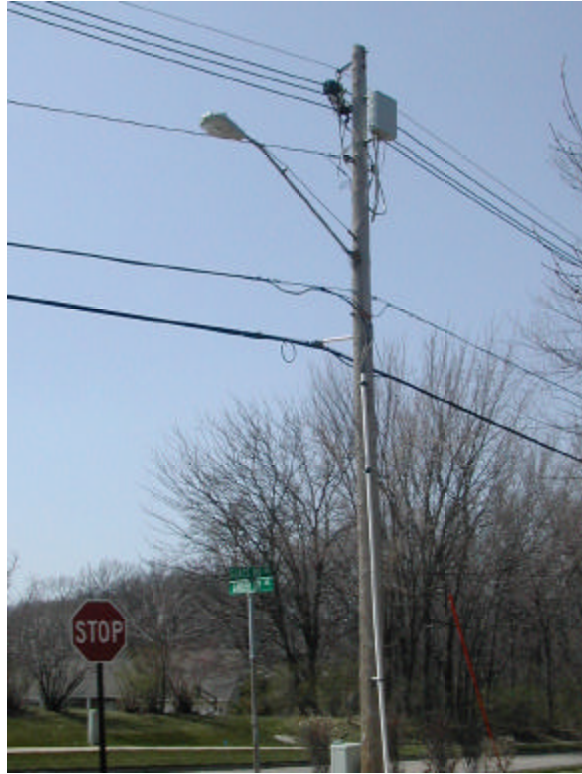
Figure 3-2: BPL Repeater at intersection of Glass Road and Amber Drive

The actual BPL hardware nearest to Mr. Spencer's Amateur Radio station is at the intersection of Glass Road and Amber Drive, shown below. (The BPL repeater is the gray box located on the right hand side of the power pole, near the top.)

This location is southwest of the Spencer residence. Figure 3-3 is a view taken from Mr. Spencer's property looking toward the northeast. The roadway extending across the picture, in the foreground, is Tanager Drive, which runs approximately northwest-southeast in this area and is generally parallel to Glass Road. The intersecting roadway is Amber Drive. The power lines carrying the BPL signals along Glass Road are visible in the background.

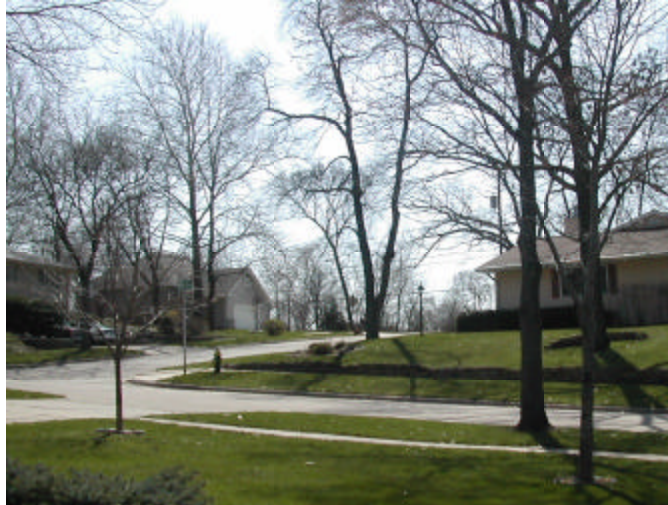
Figure 3-3: Intersection of Amber Drive and Tanager Drive, as viewed from the Spencer residence

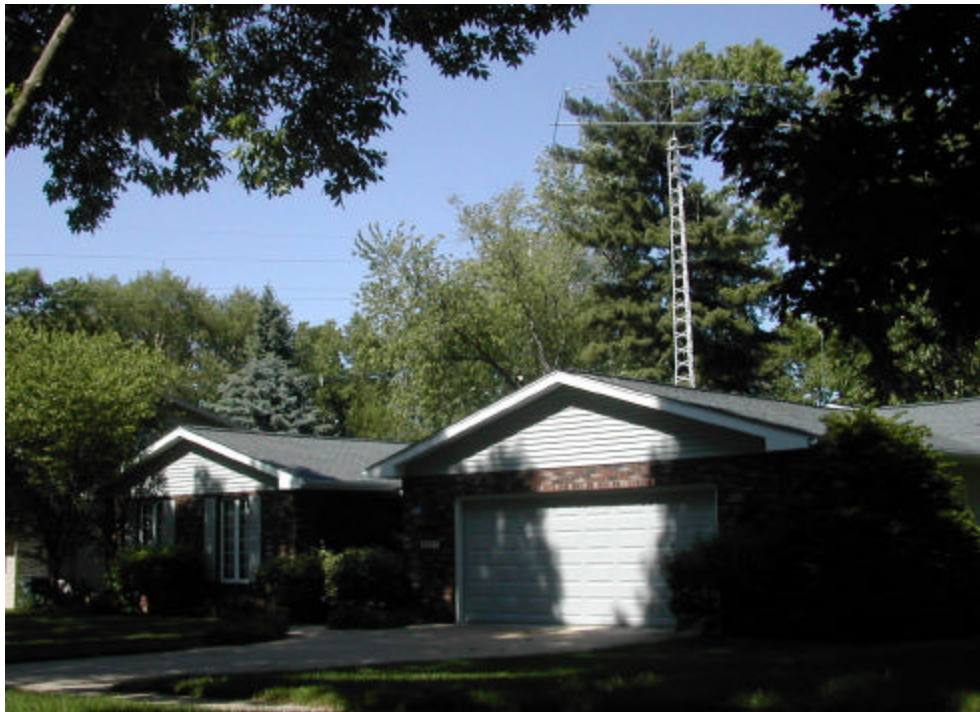
Figure 3-4: View of the Spencer residence showing front of the house and the back yard antenna tower. Other neighborhood distribution lines are visible above the house roof, in the open sky area.

Figure 3-4 is a view of Mr. Spencer's residence looking toward it from the direction of the Amber Drive-Tanager Drive intersection. Not clearly visible, but present in the background of this photo, are another set of overhead power lines which run approximately east-west (shown in Figure 3-1 map in blue) and appear to be a branch-off from the Glass Road lines. (A small portion of the branch power line is visible in the area just above the house roof.)

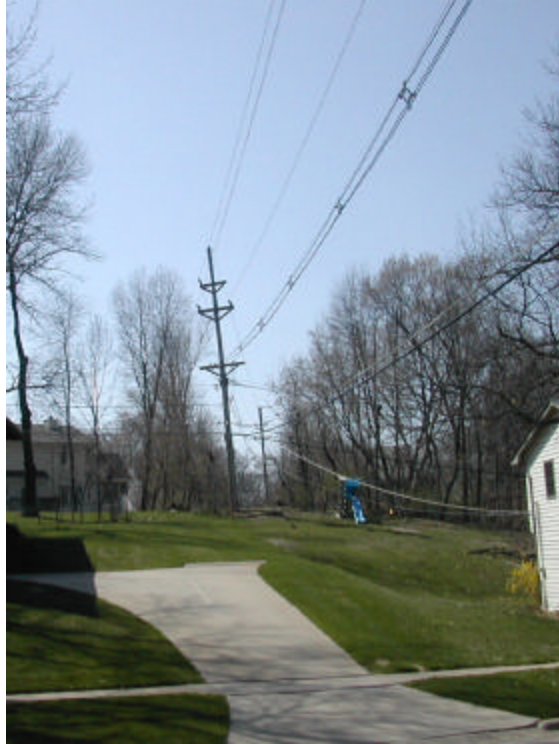
Figure 3-5: View to the west from Tanager Drive, looking toward Glass Road. These power lines are connected to Glass Road lines, but are not equipped with BPL communications hardware boxes. These lines are just west of the Spencer residence.

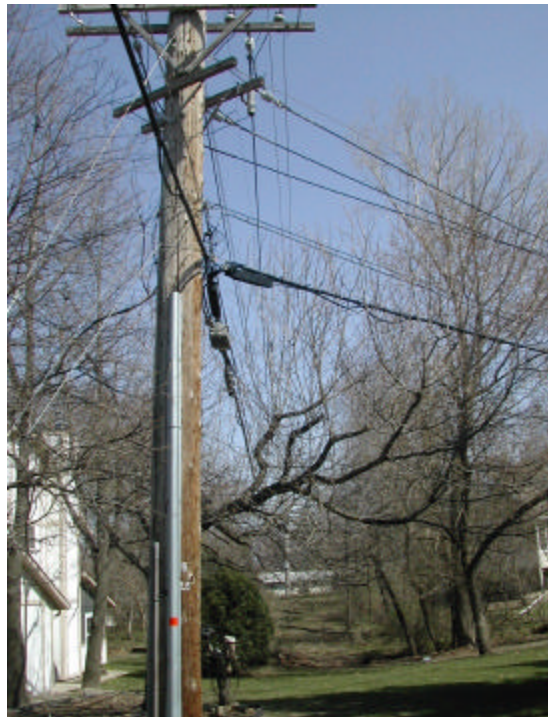
Figure 3-6: View to the east from Glass Road looking toward Tanager Drive. This is the connection point for the above circuit.

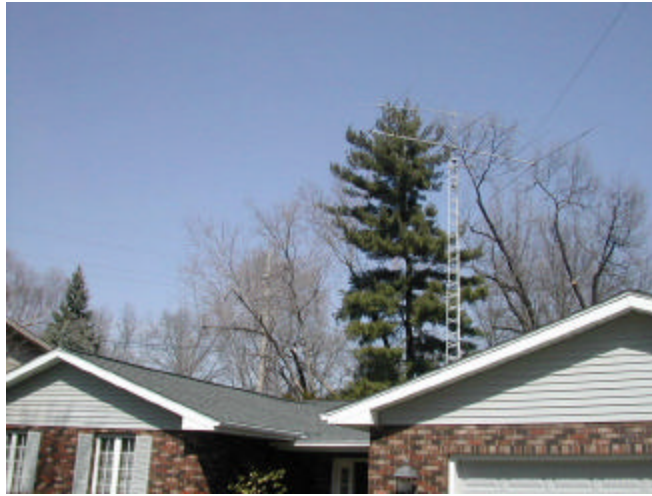
Figure 3-7: View from Tanager Drive of WØSR antenna tower

Figure 3-7 shows the antenna support tower and some of the antennas used in the operation of station WØSR. This view is toward the front of the house.

- ❖ Tower: Commercial self-supporting steel type, 48 feet overall height
- ❖ Antenna mounting: Side arms on tower for wire antennas; rotating mast for the Tri-Band Beam and WARC Dipole.

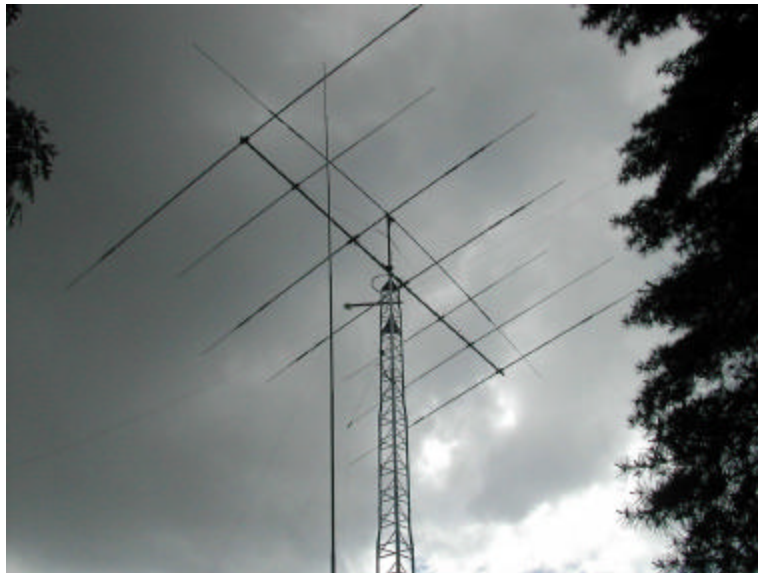
Figure 3-8: General view of antennas: (top to bottom) WARC band dipole; TH7-DXX Tri-Bander; side arm support for Inverted-V; top of ground-mounted vertical is in foreground.

The following figures show the actual antennas as they exist and as used for measurement purposes:

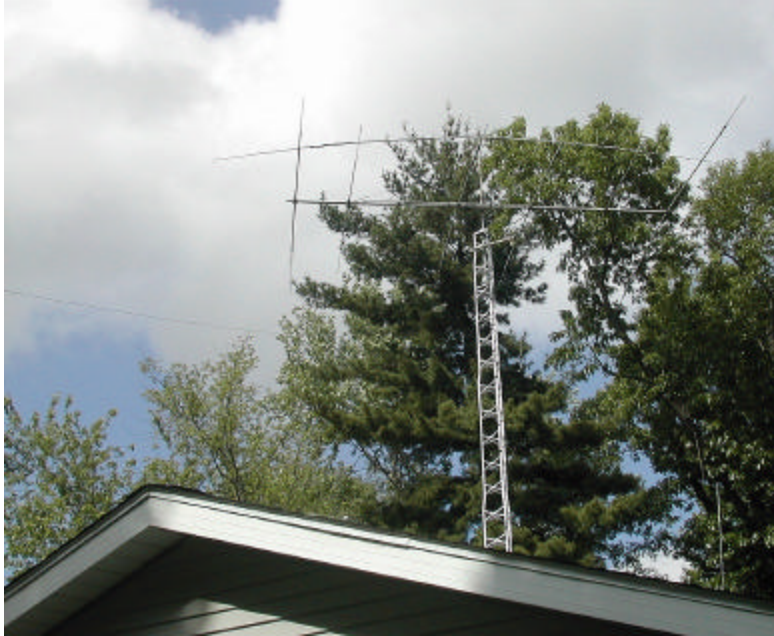
Figure 3-9: The 160m Inverted-L antenna is a horizontal wire visible to the left of the tower, above the roof peak.

- ❖ 160 m Antenna (1.8 to 2.0 MHz): Inverted-L (wire) supported by the tower at 46 feet, coax is RG-58, 32 feet long. This antenna runs from the tower at a compass bearing of approximately 240 degrees.

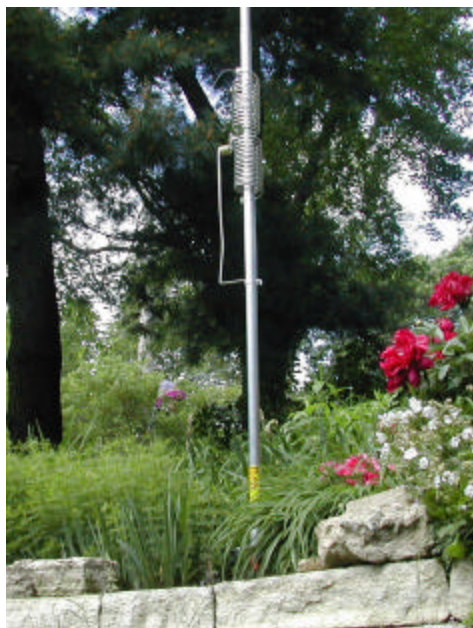
Figure 3-10: Base of Vertical

- ❖ 80/40 Vertical (3.5 to 4.0 MHz and 7.0 to 7.3 MHz) : Butternut™ HF-2V, ground mounted, fed with 45 feet RG-213 coax, and fitted with approximately 60 radials buried just below the surface of the ground.

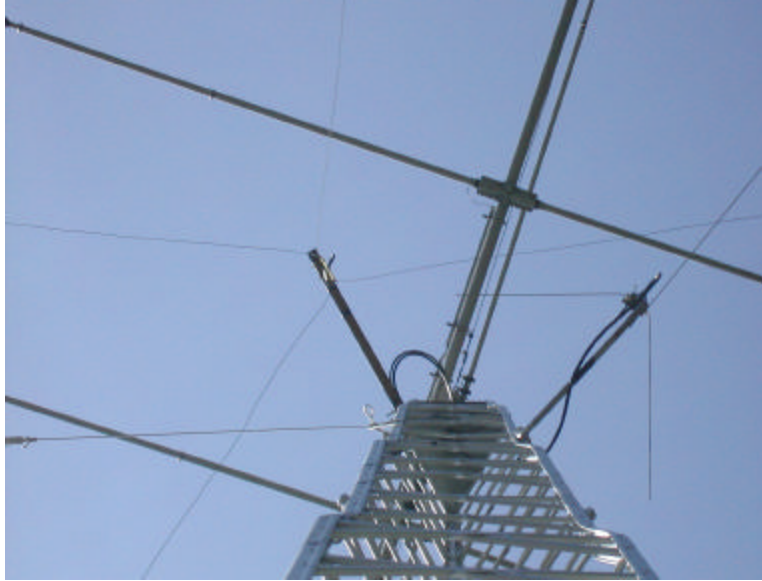
Figure 3-11: Sidearm mount for 80-40 meter Inverted-V

- ❖ 80m/40m Inverted-Vee (3.5 to 4.0 MHz and 7.0 to 7.3 MHz): Two dipoles (wires cut to resonate at about 3.8 and 7.15 MHz, respectively) supported at their apex by the tower at 47 feet, fed from a single RG-213 coax, 75 feet long. The 80m antenna runs at a compass bearing of approximately 20/200 degrees, and the 40m runs at 110/290 degrees.

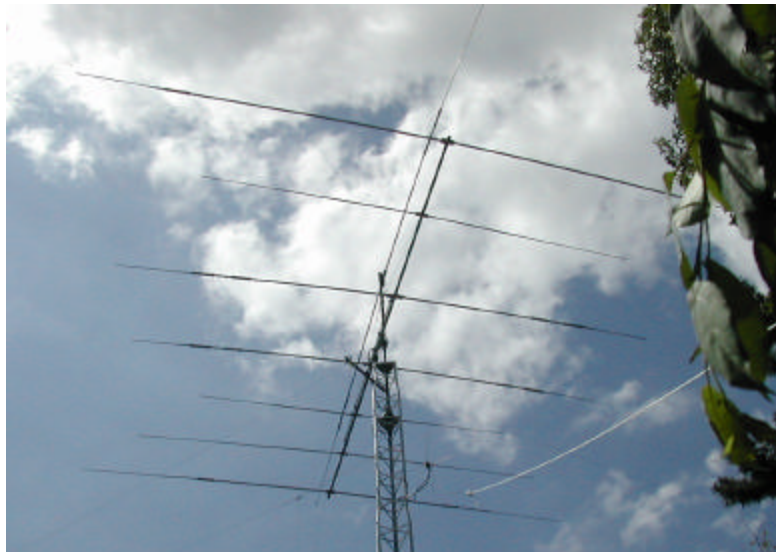
Figure 3-12: Tri-Band Beam and WARC Dipole, and one side of the 40m Inverted-V

- ❖ Tri-Band Beam³: Hy-Gain™ TH7-DXX (Yagi-type) at 49 feet fed with RG-213 coax, 75 feet long. This antenna is rotatable.
- ❖ WARC Dipole⁴: Cushcraft™ D3W rotatable dipole at 54 feet fed with RG-213 coax, 80 feet long. The antenna is a single element dipole which

employs traps as tuned elements for each of the bands. It is mounted above the Tri-Band Beam on the tower mast and is orthogonal to the orientation of the Tri-Band Beam.

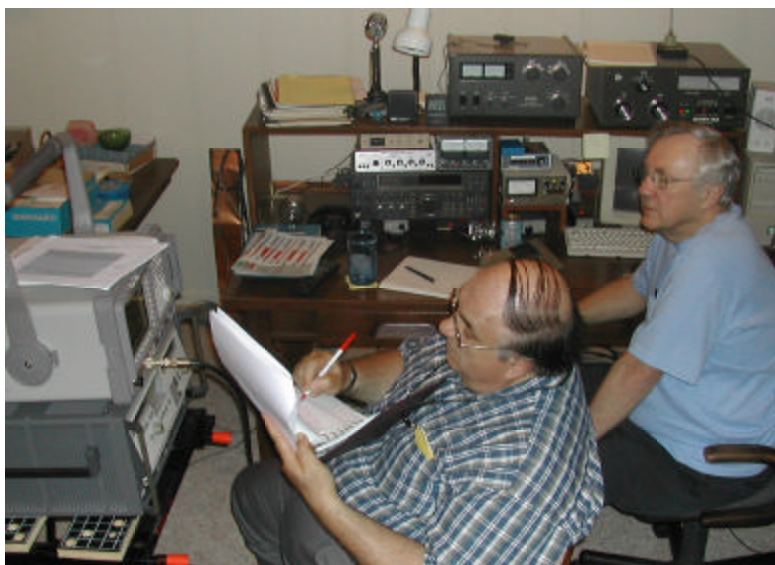
Fig. 3-14: Mr. Dale Svetanoff takes notes as Mr. Spencer looks on. The Agilent E4411B spectrum analyzer is sitting atop the Wandel & Goltermann SPM-17 Level Meter. Either instrument may be connected to the regular radio station coaxial cable as required. (The coaxial cable is the black cable shown connected to the input connector of the Agilent E4411B in the above photo.)

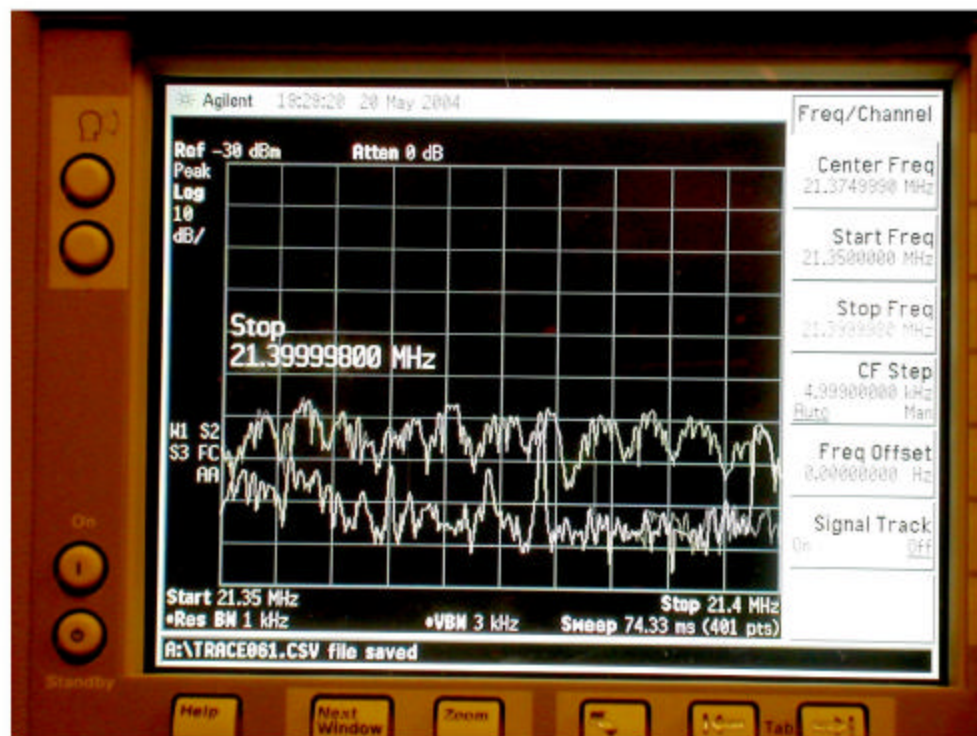
Figures A1B-3 (upper) and A1B-4 (lower)

These figures each show two successive sweeps from 21.35 MHz to 21.4 MHz in which the BPL signals were transitioning between levels. The average level change across the frequency span was about 20 dB, although some carriers went to a peak as most of the others lowered. Figure A1B-3 actually caught the transition in progress (right end of trace).
